JPL Publication 16-2

Mars Exploration Rover Spirit End of Mission Report

*John L. Callas
Mars Exploration Rover Project
Jet Propulsion Laboratory*

END OF MISSION REPORT

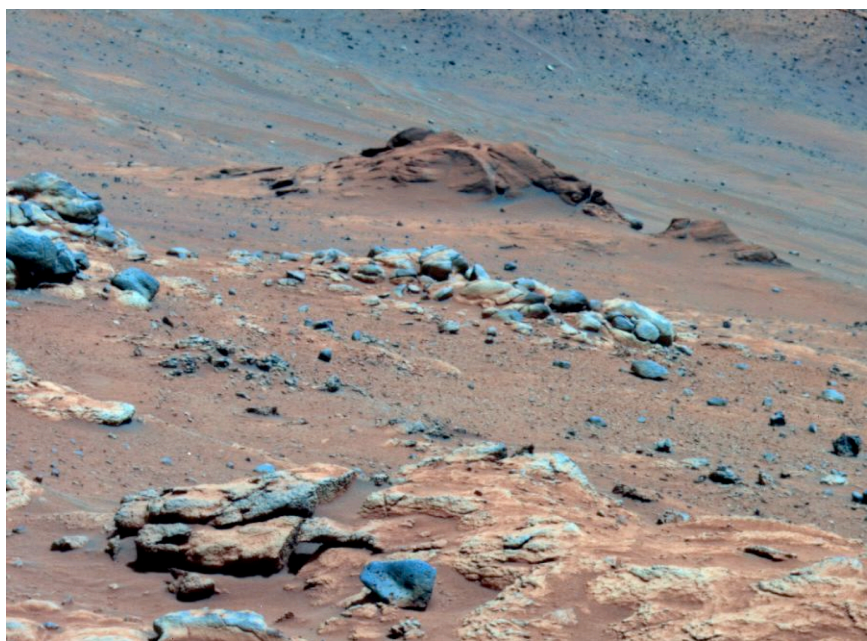
Figure 1.3 Color Pancam image from Sol 689 of the “Comanche” outcrop.

A detailed and painstaking joint analysis of Mössbauer, APXS, and Mini-TES data acquired on the Comanche outcrop near the top of Husband Hill (see Figure 1.3) revealed the presence of significant amounts of iron and magnesium carbonate minerals in these rocks. Previously, carbonates were found in ALH-84001 and CRISM spectra of Nili Fossae, but this is the first positive identification of this important mineral in its geologic context. The

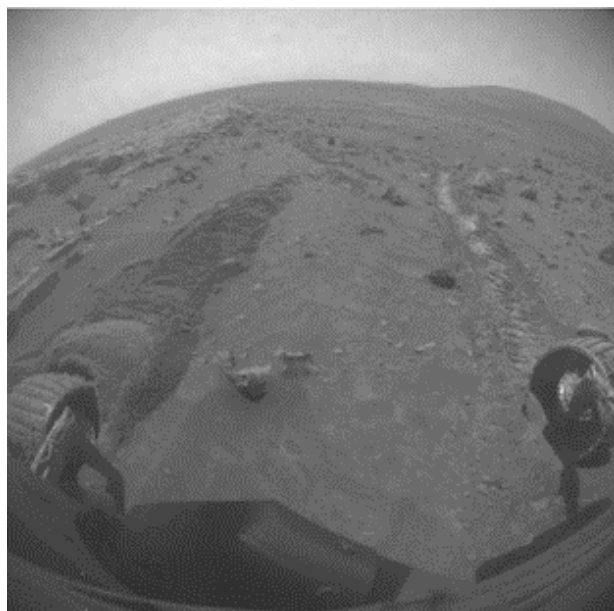
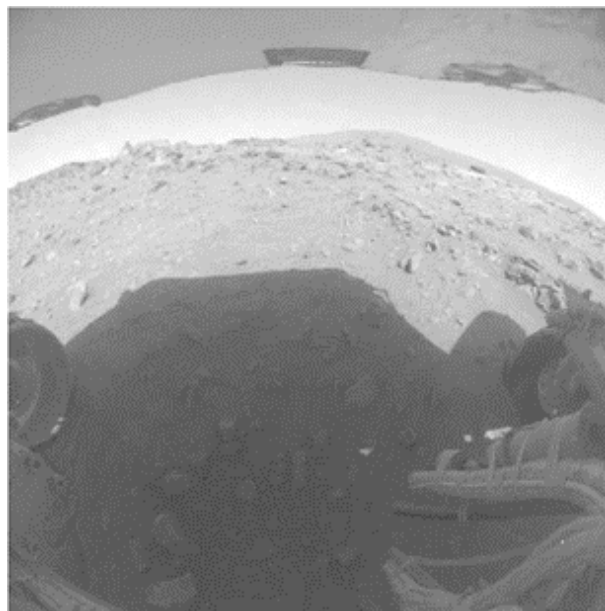
Figure 6.1 Sol 1818 Hazcam images showing the embedding of the rover wheels.

After Sol 1800, Spirit began the move along Route 1, the traverse up onto Home Plate. Soon the rover began to experience difficulty negotiating terrain with moderate slopes. Figure 6.1 shows the Sol 1818 Hazcam images of the embedding that was occurring. After making extensive efforts, the project abandoned Route 1 on Sol 1829 and made the decision to pursue Route 2.

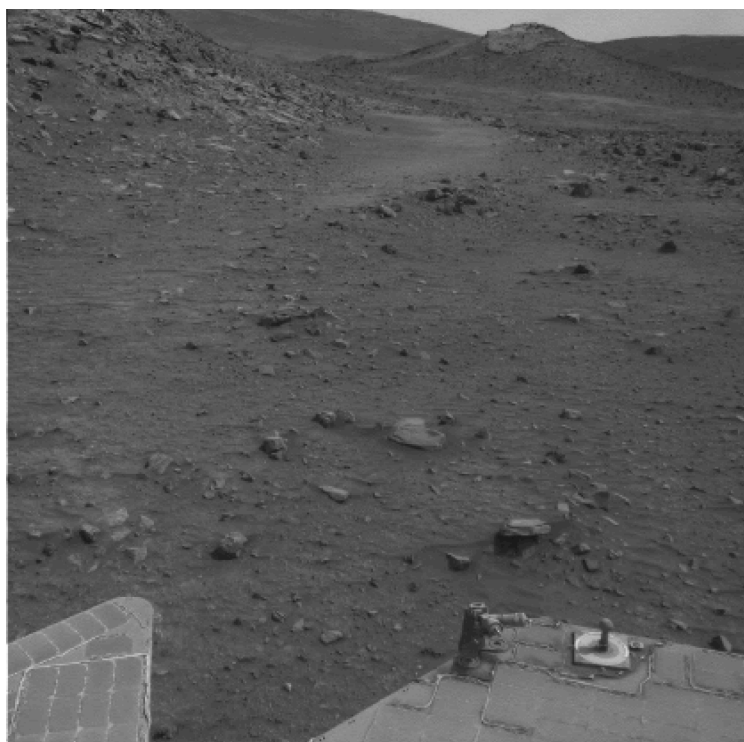
Figure 6.5 *The Sol 1870 Navcam just prior to embedding at Troy. The embedding location is approximately dead-center of the image.*

Spirit initially made good westward progress along Route 3. Figure 6.5 is a Sol 1870 Navcam image showing an apparently hazard-free traverse path. But on Sol 1886, Spirit began to become embedded in a location on the west side of Home Plate, now called “Troy.” Realizing the onset of embedding, the project, just as it had done for the embedding on Routes 1 and 2, made several tactical attempts to extricate the rover. But after several unsuccessful tries, on Sol 1899 a stall of the left middle wheel occurred. Upon investigation of the wheel stall and an assessment of the terrain, the project stood down from mobility operations. Figure 6.6 shows the Sol 1899 Hazcam images of the embedded rover wheels. Figure 6.7 summarizes the events leading up to and including the embedding at Troy.
